THESIS

AN INVESTIGATION INTO THE TRIPPING BEHAVIOR OF
LONGITUDINALLY T-STIFFENED RECTANGULAR FLAT PLATES
LOADED STATICALLY AND IMPULSIVELY

HOWARD L. BUDWEG

March 1986

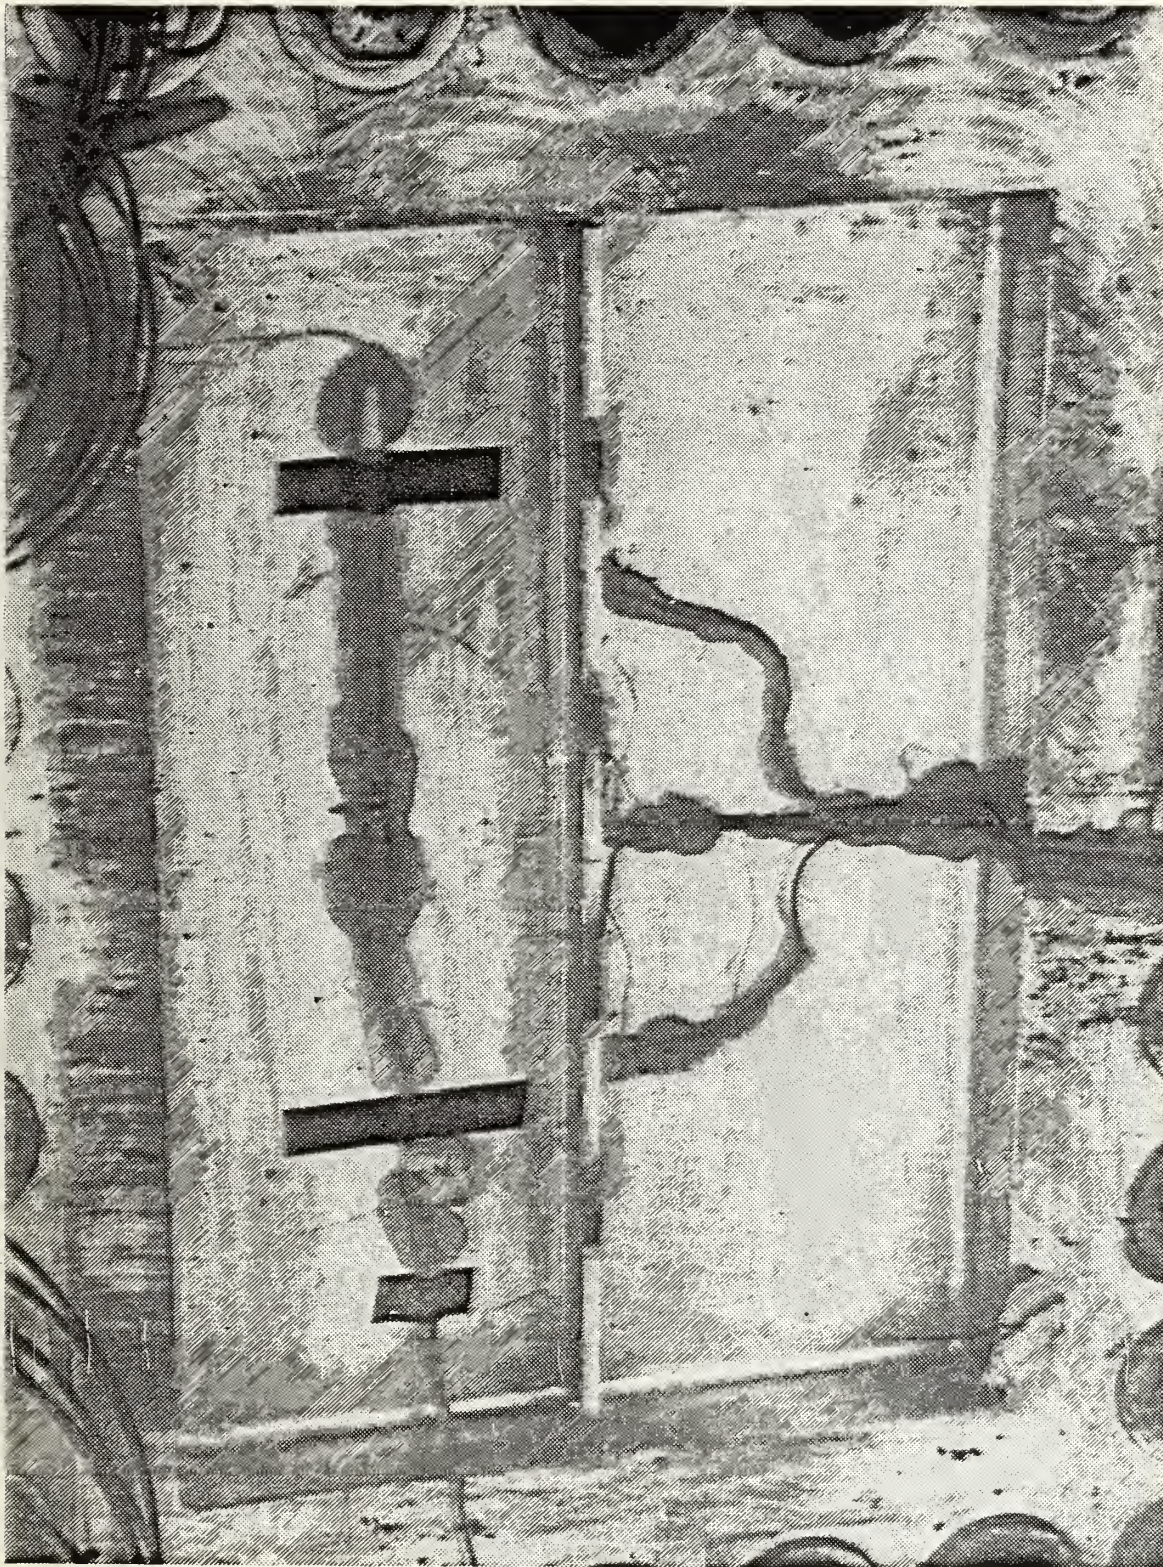
Figure 3.7 Strain Gage and Pressure Transducer Placement (waterside).

Strain measurements were taken on both the water exposed side and the air-backed side of the test panel as shown by Figures 3.7, 3.8 and 3.9 . The strain gage placement was determined on the basis of symmetry and the stiffener position. Consequently, the strains observed should be consistent with their position on the plate and would approximate the values and trends exhibited by symmetrically equal positions on other portions of the plate. Additionally, gages on the stiffener flange should be the first to show tripping effects, with the longitudinal array of three gages on the airside centerline soon mimicking the same trend.
